Technical Report CHL-99-3

Monitoring Completed Navigation Projects Program

Inspections of Previously Monitored Coastal Structures

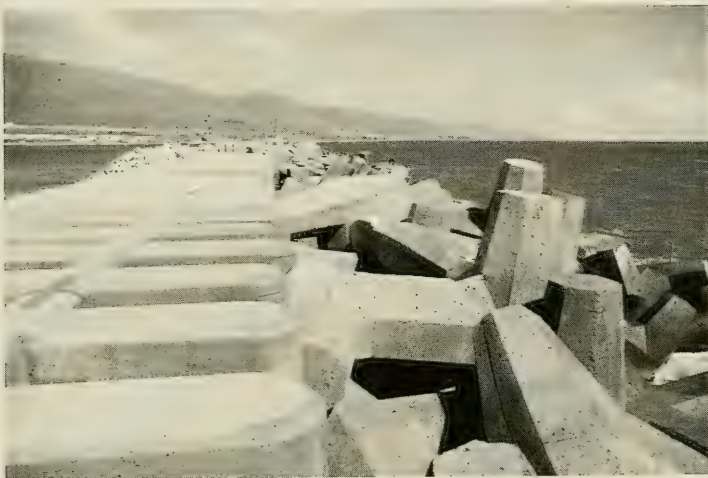
The Kahului Harbor breakwaters were inspected on 21 July 1998. The inspection, as close as could be observed visually, indicated that most of the armor unit positions were similar to those obtained during the 1993 survey. Views of the structures are shown in Figures 6 and 7. On the east breakwater it appeared that two 31,750-kg (35-ton) tribars had flipped and slid downslope slightly on the sea side of the structure at approximately sta 10+50. Additional breakage of some of the 5,445-kg (6-ton) dolosse

Figure 6. Kahului east breakwater

(sta 6+20 thru 7+10) on the sea side of the structure was noted since the 1993 survey. Eleven broken units were observed in this area as opposed to nine documented broken units during the 1993 survey. During the west breakwater inspection, a concentration of broken 27,215-kg (30-ton) dolosse was noted on the sea side of the head. Twelve broken/cracked units were observed versus eleven documented during the 1993 survey. Also, some of the 5,900-kg (6.5-ton) tribars on the harbor side of the breakwater close to its head appeared to have lifted and tilted downslope

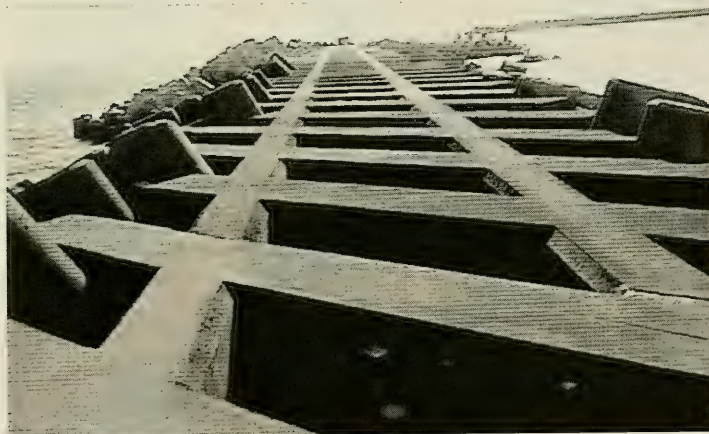
Figure 7. Kahului west breakwater

(possibly due to overtopping waves, Figure 8). No voids and breaches were noted in the breakwaters, and the overall condition of both structures was considered good.

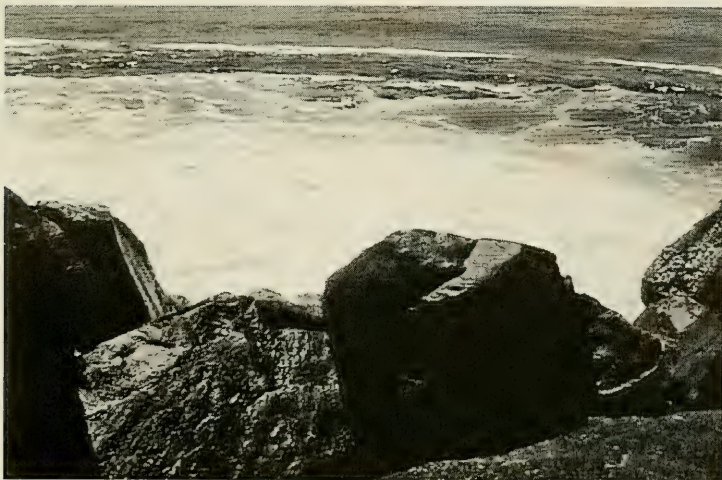
Figure 18. South jetty head at Siuslaw

slopes of the south jetty system were in good condition, with the exception of the jetty head and the jetty spur head as previously discussed.

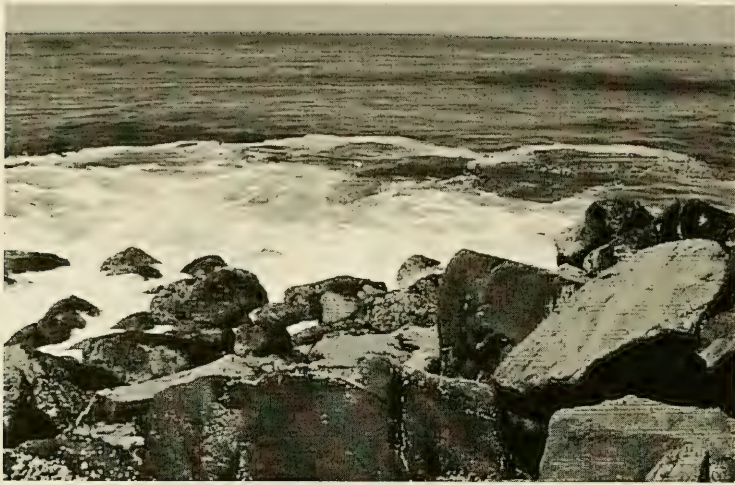
Figure 19. Head of Siuslaw River south jetty spur

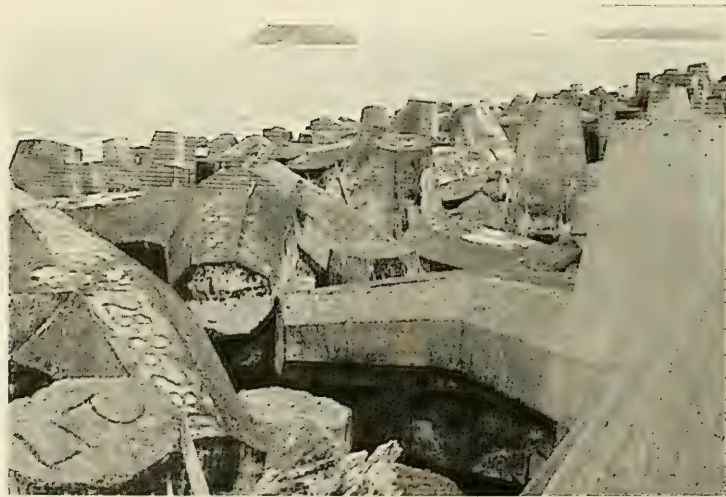
The Crescent City Harbor breakwater (Figure 27) was inspected on 15 September 1998. The inspection indicated that most of the armor unit positions were similar to those shown in the 1993 photography as close as could be observed visually. It appeared that only a couple of the 38,100-kg (42-ton) units had changed positions slightly along the waterline at the outer portion of the main stem. Figure 28 shows some of these units at the head of the main stem of the breakwater. Numerous broken armor units were observed, but were validated as being broken in the 1993 survey. Overall the structure is in good condition.

Figure 28. View of 38,100-kg (42-ton) dolosse on the sea-side slope of the main stem of the Crescent City breakwater

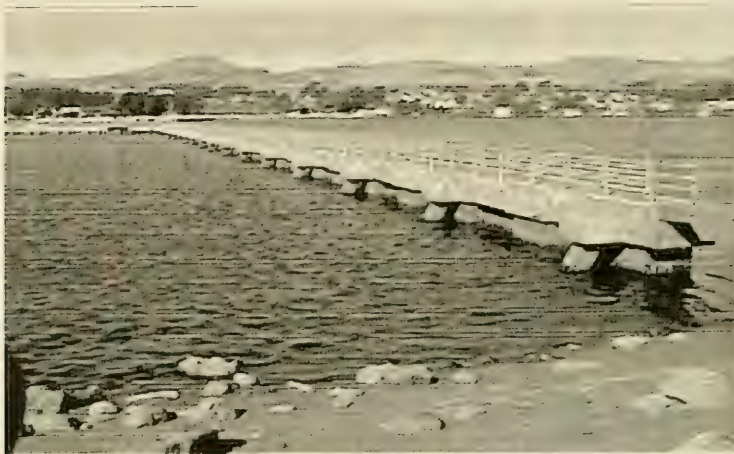
The Spud Point Marina breakwater (Figure 30) was inspected on 16 September 1998. The assessment revealed no evidence of misalignment, movement, spalling, or subsidence of the structure. The hairline cracks across the top of the breakwater cap noted in the earlier surveys did not appear to have widened (Figure 31). Additional hairline cracks were observed, particularly on the vertical sides of the cap. Some of these cracks

Figure 30. View of marina side of shoreward leg of Spud Point breakwater

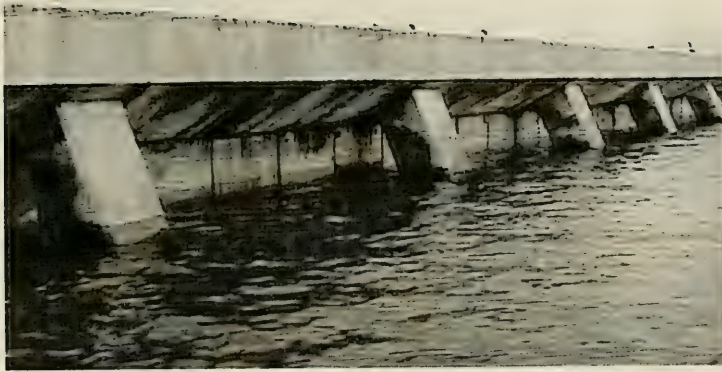
The Fisherman's Wharf breakwaters were inspected on 17 September 1998. Visual assessment of the structures was conducted by running a boat along the sides of the breakwaters and walking the main breakwater cap. A portion of the main detached breakwater is shown in Figure 34. The inspection revealed no deterioration or apparent settlement of the breakwaters. Numerous areas along the concrete piles between the main breakwater cap and the waterline were spalled (Figure 35). These areas are not threatening the structural integrity or function of the structure. The overall condition of the breakwaters was very good to excellent.

Figure 34. Portion of detached breakwater at Fisherman's Wharf Harbor

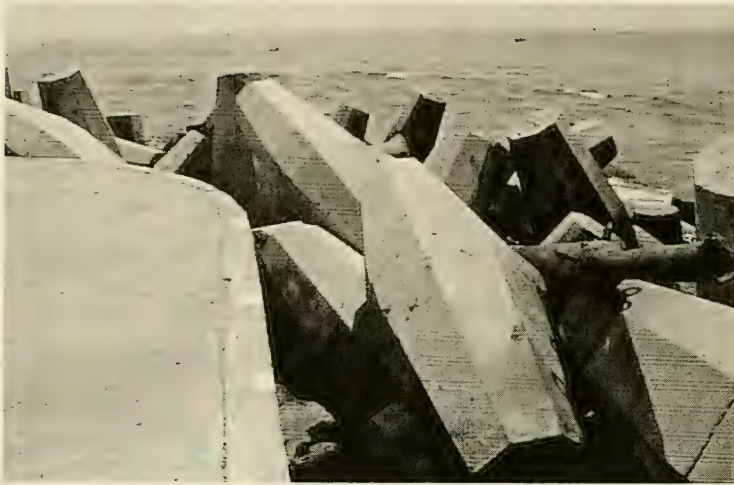
The Manasquan Inlet jetties were inspected on 10 June 1997. The 14,515-kg (16-ton) dolos armor units are shown in Figure 49. Visual comparisons of armor unit positions on the north jetty to 1994 photomaps revealed that several units had moved slightly. Horizontal movement appeared to range from 0.15 to 0.6 m (0.5 to 2 ft). In addition, it appeared that the downslope portions of most of these units had slightly lost

Figure 49. 14,515-kg (16-ton) dolos armor units on Manasquan Inlet jetties

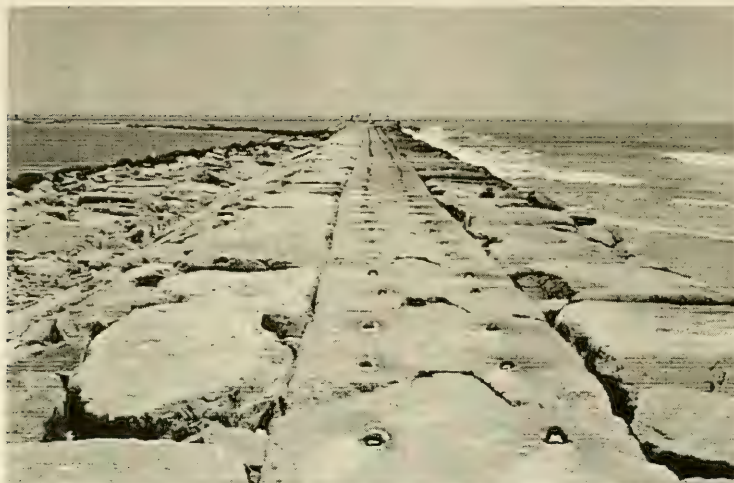
The rehabilitated south jetty and headland breakwaters at Ocean City Inlet were inspected on 11 June 1997. The rehabilitated south structure is shown in Figures 54 and 55, and the headland structures are shown in Figure 56. The inspection revealed these structures to be in excellent condition. No voids were noted, no armor stones were broken, and the cross sections of the structures appeared to be as built. It was noted that the seaward section of the old south jetty (that extending beyond sta 13+00) was in disarray. Armor stones were scattered, the crest height was inconsistent, and no definite cross section was apparent (Figure 57).

Figure 54. Rehabilitated south jetty trunk at Ocean City Inlet

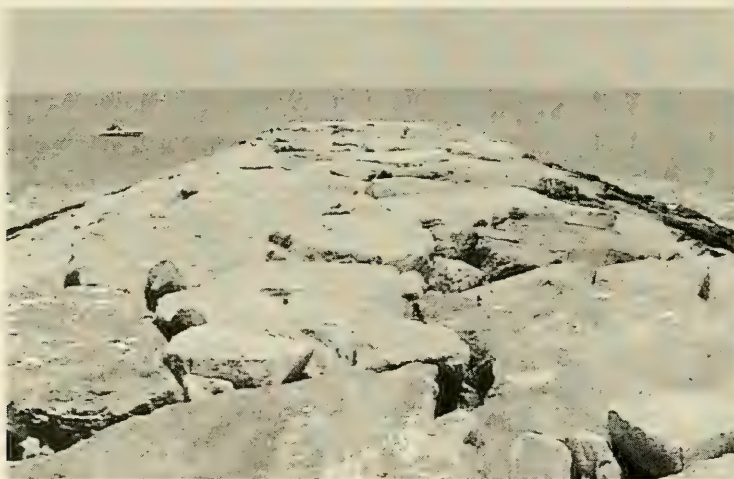
Figure 55. Head portion of south jetty rehabilitation at Ocean City Inlet

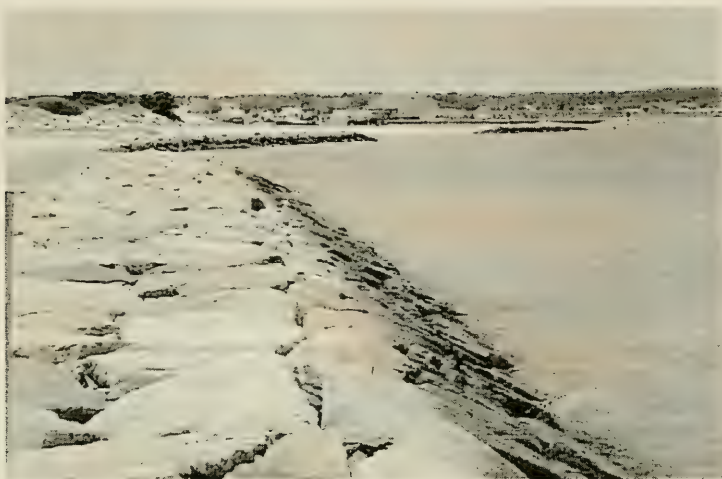
Figure 56. Headland breakwaters at Ocean City Inlet constructed to stabilize shoreline
